## ASSESSMENT OF THE LEVEE SLOPE STABILITY AT LABOREC RIVER, SLOVAKIA

Levee failures due to floods may result in extensive damage to agricultural land, rural and urban infrastructures as well as human. Manuscript deals with failure and the calculation and assessment of stability of right bank protective levee at Laborec River, and suggests possible remedial measures, such as stabilizing mound, raising the levee crest and drainage of levee body. Classification of embankments, legislation dealing with protective embankments and valid standards, designing and description of failures of protective levees are also briefly mentioned in the paper. GEO 5 programme for geotechnics calculations using Petterson's and Bishop's methods were applied for levee stability assessment. Calculations were done for more alternatives. Better results were found out according to applying Bishop's method.

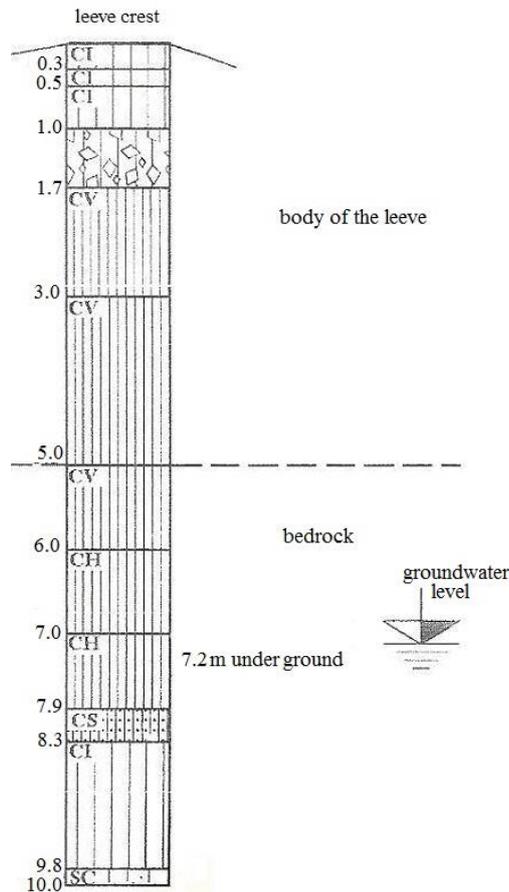
Fig. 2: Geological profile of the levee body and its bedrock in the place of disturbance [9]

The levee is a homogeneous and its construction material is from its surroundings. Height of the levee body is up to 5 m. In terms of use it is understood as a major levee. Level of groundwater was found at a depth of 7.2 m below the levee crest. This water is percolating from sands verified at a depth of 10.0 m below the levee crest. Groundwater level is

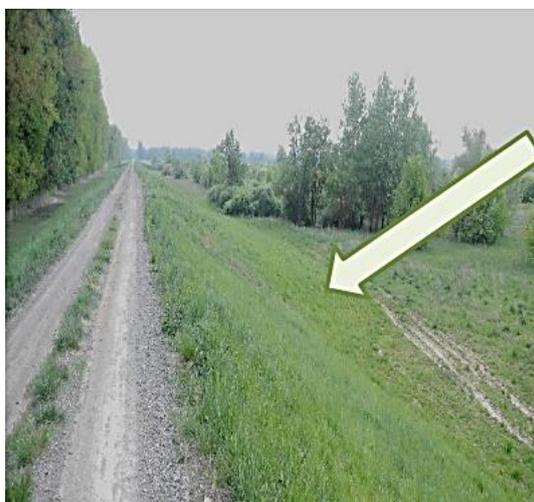
increasing mainly during the flooding. According to information from the catchment area, a landslide of downstream face of a levee was originally seen on 21<sup>st</sup> May 2010, at 3.4 kilometer, along the right bank of the river Laborec, in length about 20m, with a decrease of soil about 30cm. Occurrence of landslides were observed during the following days. On 25<sup>th</sup> May 2010, cracks in the landslide were stabilized with Bentovet K (bentonite) [9]. Between 2<sup>nd</sup> June and 5<sup>th</sup> June 2010 further decline in soil has occurred. On 2<sup>nd</sup> June 2010, the enlargement of crack and further declination of the levee crest and downstream slope of about 30cm occurred, without visible landslide. On 3<sup>rd</sup> June 2010, levee crest and downstream slope decreased for approximately 10cm. Extension of crack continued on 4<sup>th</sup> June 2010 by a further decline in crest and downstream slope approximately for another 20cm. At this stage, landslide was associated with expanding on both slopes along the levee. At 20:00 the 3<sup>rd</sup> degree of flood activity at critical water level was subsequently declared. The water level was about 1m from the levee crest at the site of the landslide. At the time of inspection failure (27<sup>th</sup> July 2010) the edge of detached area intersects the crest of the levee that was breached in a length of about 26m. Decrease of the levee at the site of detached edge was 30 to 40cm [9].

Causes of these failures were most likely [11]:

- The material used for the construction of the levee - cores with very high plasticity (CV) which are less suitable for homogeneous dikes because of their strength when saturated with water is small and very difficult to be compacted,
- prolonged extremely high water levels in Laborec river - flooding that allowed long-term saturation of earth levee body.

The result of these two factors was subsequently loss of strength and the failure of the levee.

Figure 3 depicts the current status of the affected part of the levee; view on the failure of the levee crest is from the village Oborin. On the right side (downstream face of a levee), landslide can be seen. Since 2010, when the fault occurred, levee became completely grassed, and therefore can be identified only by the irregularity of the slope.

*Fig. 3: Disturbance of the levee on downstream face*

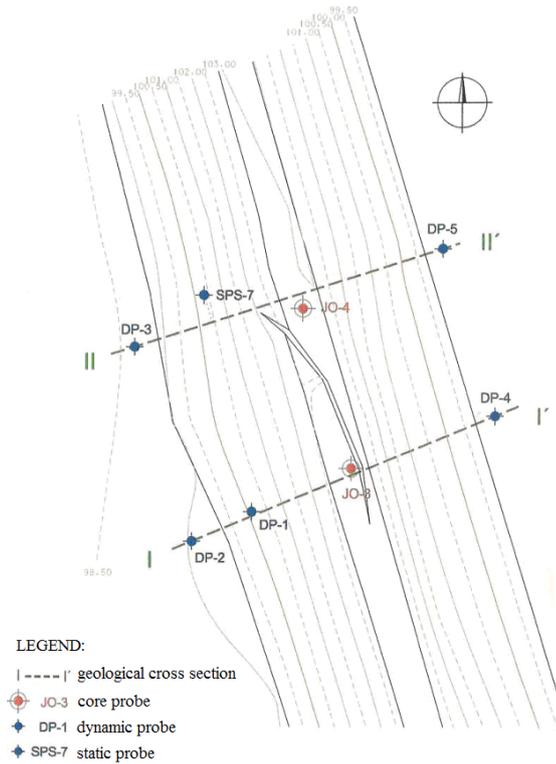
The first calculation was made for the original condition of the levee, i.e. before the flood in 2010 (Variant I), further calculation was carried out for flood conditions that arose in 2010 (Variant II). Due to the location of probes (Fig. 4) was for the stability assessment of slope in transverse sections 70 and 72 considered the geological-engineering (GE) profile according to core holes JO-3, and for the sections 74 and 76 it was made according to the GE profile core holes JO-4. The results of the calculation of mentioned variants, for the selected cross sections, are shown in Tab. 1 and 2 [11].

Fig. 4: Situation of the probes in selected area

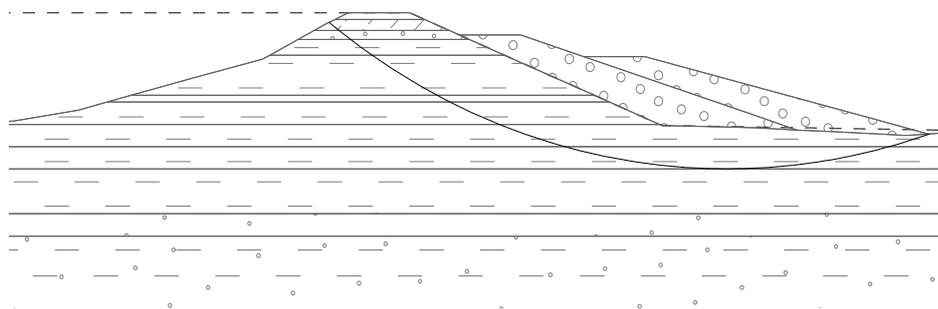
compared with the desired stability degree. The following figure 5 shows the shear stress area of the cross-section No. 74 of riprap slope stabilization made of gravel (Variant III-C).

*Fig. 5: Pettersons's method: Shear stress area after optimization - Variant III-C*

After the modeling of various shapes and heights of riprap slope stabilization of the downstream face, the most suitable solution, the double riprap of the same material has been proposed. First riprap is 1m below the crest and a slope is about 1: 3.2 and the second riprap is 2m under the levee crest in slope 1: 4. The water level in the design was considered at two levels. Initially has been considered as in Variant I, i.e. water level before the flood situation. Further calculations were made in consideration of the water level as in Variant II, i.e. during flood events. In this way, we wanted to verify the stability of the proposed remediation action in the event of another flood situation.

The aim of the riprap slope stabilization of the heel on the downstream face of the levee was to achieve a higher degree of stability than 1.5, thereby improving the stability of the slope itself. Proposal of three variants of riprap slope stabilization (Variant III. - A to C), in which material were varied should point on increased stability when using more suitable soils. Implemented on the basis of calculations and assessments, it is clear that the stabilization riprap (the Variants III-B and C) is certainly one of the possible remediation measures, but probably not sufficient for solving the stability of downstream slope for potential further flood situation. In modeling such a new flood situation similar to situation in 2010, when the water level reached the crest of the levee, this measure did not show as sufficient.
