DEVELOPMENT OF THE REVITALIZED STREAM - THE EXAMPLE "HRANIČNÍ STREAM" IN ORLICKÉ ZÁHOŘÍ

Jana Marková^{1*}, Jitka Fialová¹, Pavla Kotásková¹

To cite this paper: *Marková, J., Fialová, J., Kotásková, P. (2014). Development of the revitalized stream - the example "Hraniční stream" in Orlické Záhoří, In conference proceedings of People, Buildings and Environment 2014, an international scientific conference, Kroměříž, Czech Republic, pp. 671-683, ISSN: 1805-6784.*

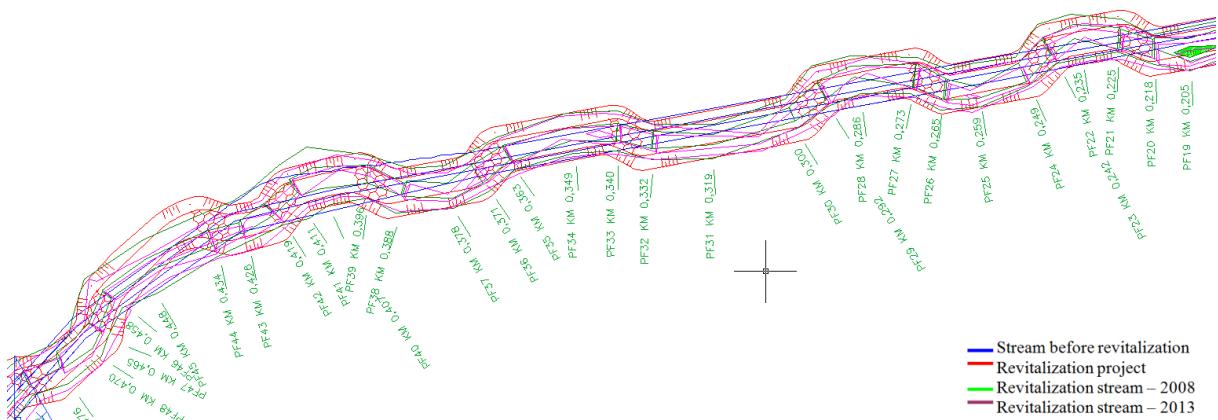
Fig. 1: Part of the reference flow (aut. Marková)

Based on the monitoring we can conclude that the flow path is still holding the designed curvature for ten years since the revitalization executed. Alternation of directional arches and directing of the stream on the stone chutes. The streambed is gradually creating places, where it comes to branching of the stream due to overgrowing of the sediments. See the situation Fig. 1

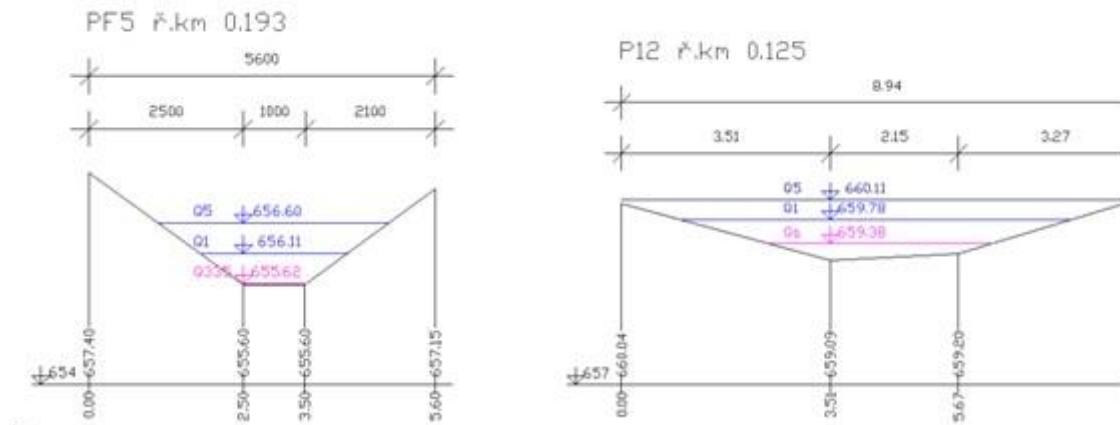
Fig. 2: Cross profile, before and after revitalization (aut. Marková)

Adjusted profile of a simple trapezium shape, with width in the bottom of 1 m and slope gradient 1:1 was replaced with a wide streambed with the width in the bottom approx. 3 m and the slope gradient approx. 1:3 and depth approx. 0.4m- within the revitalization in 2004. While measuring the streambed in 2008 and in subsequent processing in the Atlas and Auto-CAD programs it was verified that it has not come to any significant change in the shape of the cross profile within the last four years since the revitalization performed. While assessing the state measured in 2013 the changes have already been registered. The cross profile was very irregular the total width of the level is maintained; the banks were undermined and covered with grass turfs. The width in the bottom from 3m to 6m. See Fig. 2

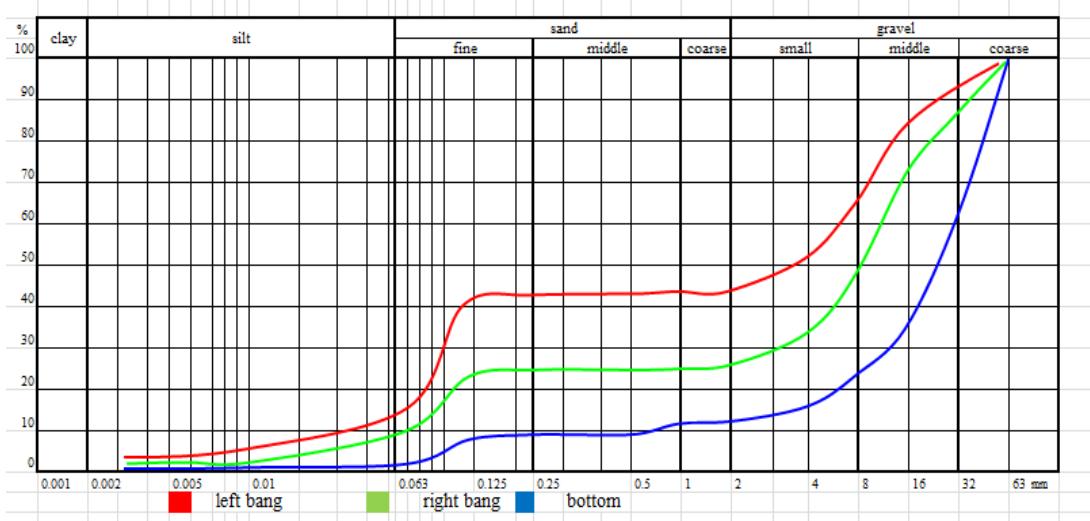
Fig. 3: gradation curve-stream after revitalization – 2008 (aut. Marková)

Classification of soil: bottom - well grained gravel, left bank - clayey gravel, right bank - clayey gravel.

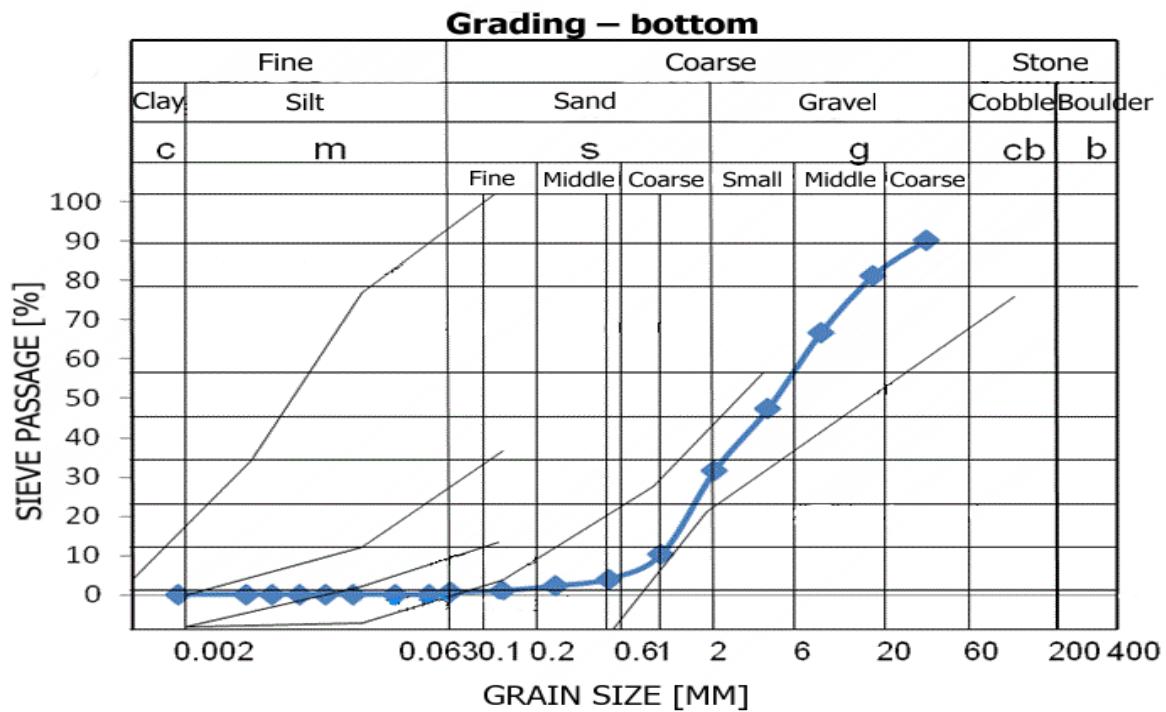
Fig. 4: gradation curve-bottom after revitalization – 2013 (aut. Marková)

It is a coarse grained soil, namely: coarse grained sandy medium grained gravel (cosaMGr)

The results of the grain size analysis of the bottom on the screens are distorted by exclusion of grains larger than 0.1m that are represented in the bottom pavement. At samples taken in 2008 this correction was not done as the bottom pavement did not show such frequent representation of these larger particles.

Based on classification and visual impression at the field survey, it is obvious that it comes to change of the sedimented material size and change of the bottom pavement in the whole section

revitalized. There are stones of larger diameter than before in the streambed and the particles sized over 0.1m of elongated shape form a substantial proportion.

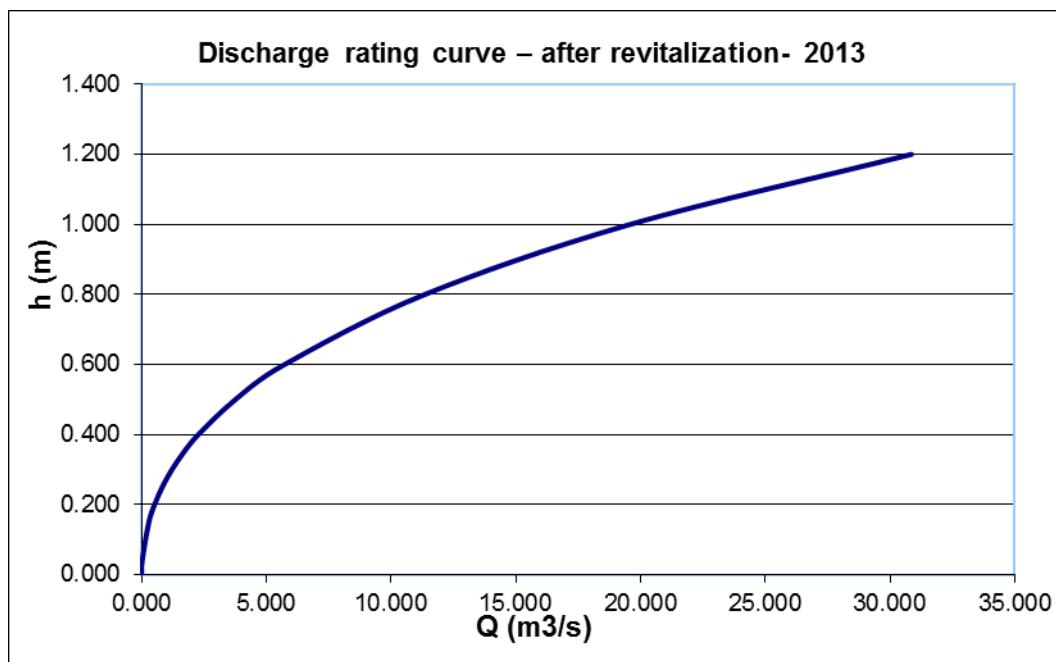
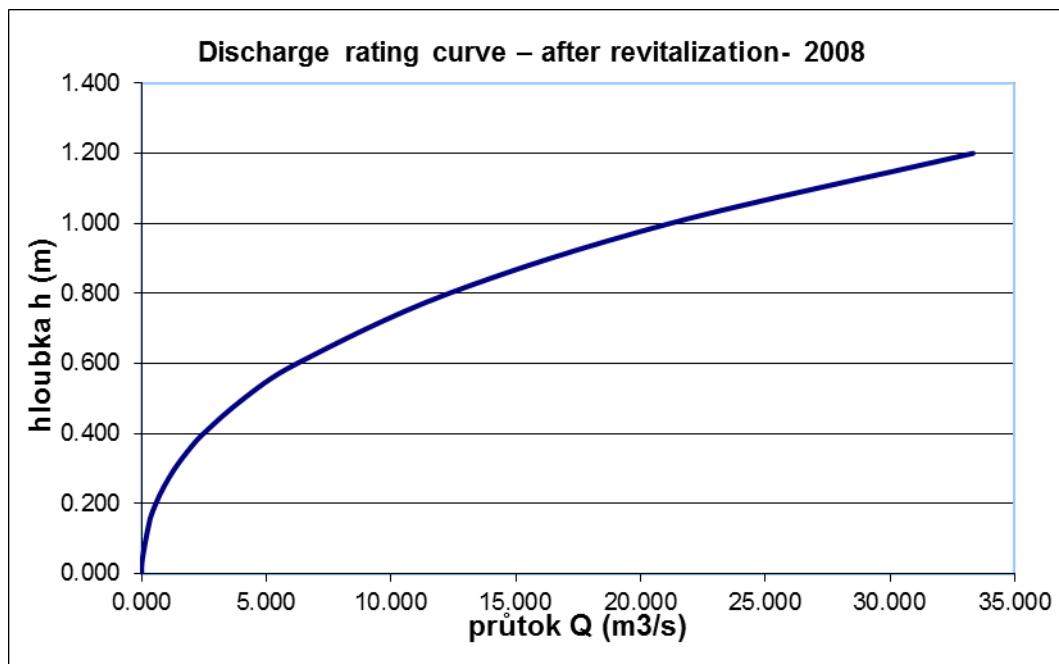
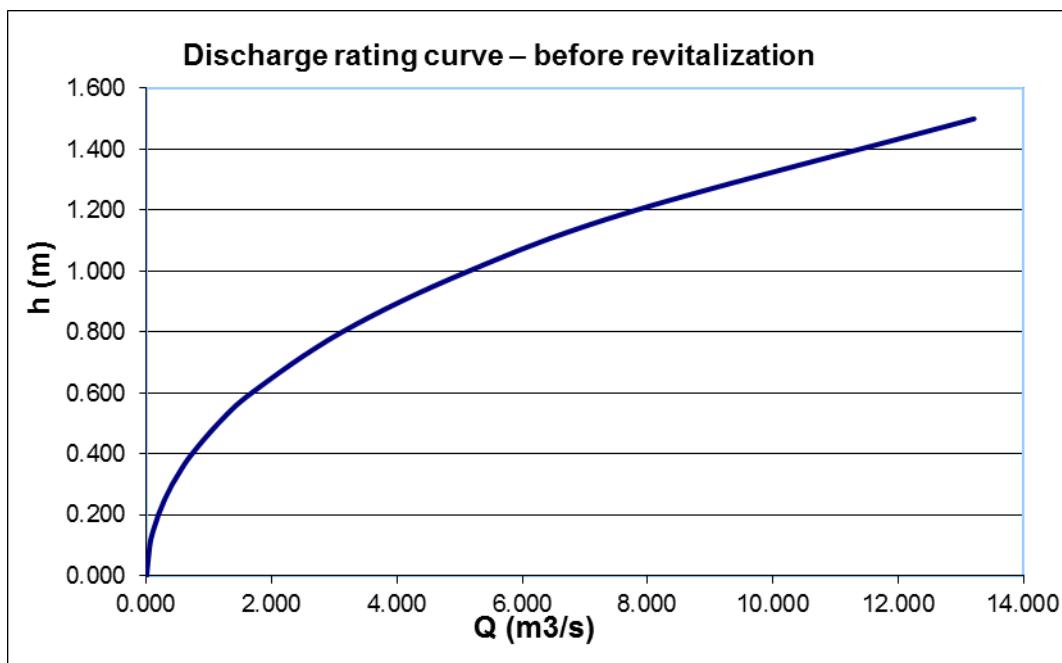
Capacity channel after revitalization stays at about 4.5 m^3 , approximately Q_5 despite changes occurring in the transverse profile occurs.

Fig. 5: Discharge rating curve – after revitalization- 2013 (aut. Marková)

Fig. 7: *Discharge rating curve – after revitalization- 2008* (aut. Marková)

Fig. 9: Discharge rating curve – before revitalization (aut. Marková)

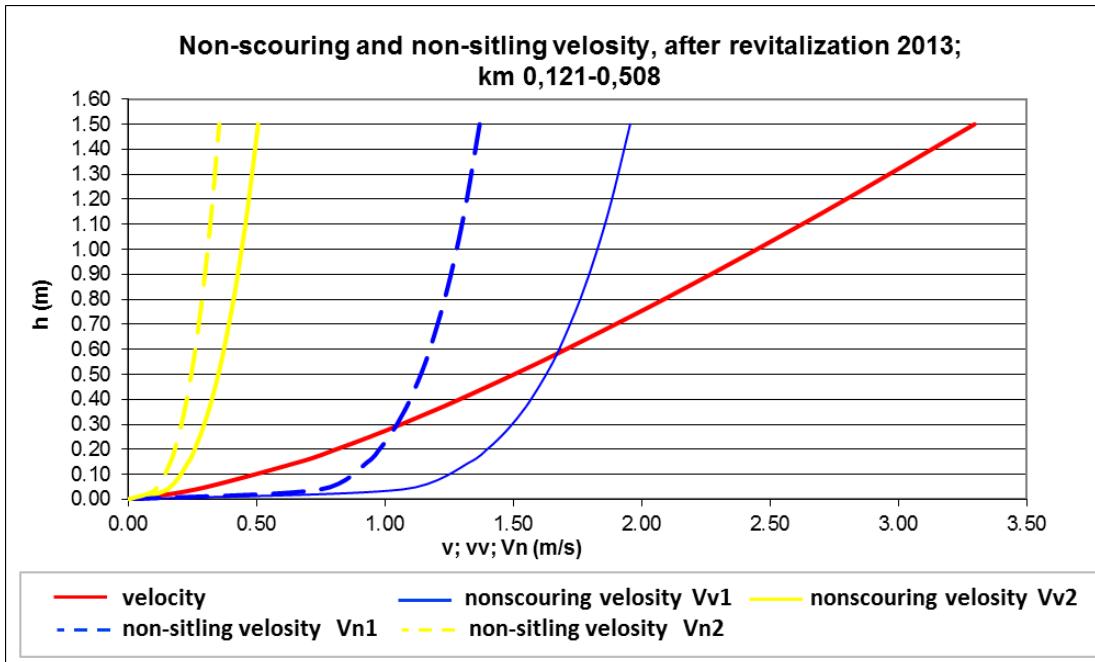
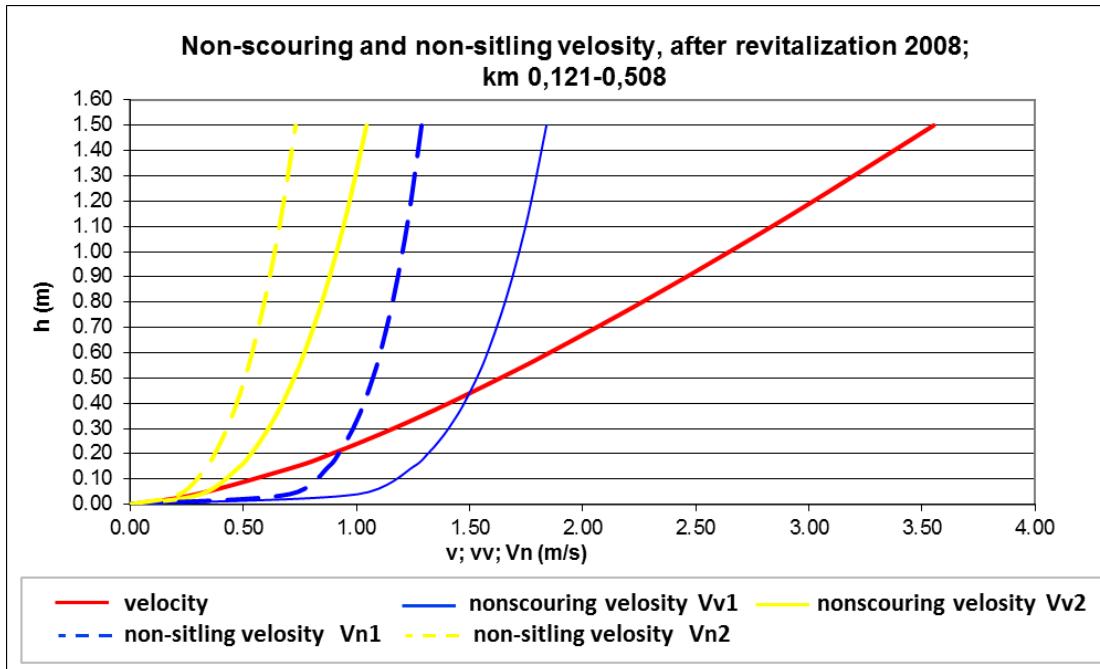
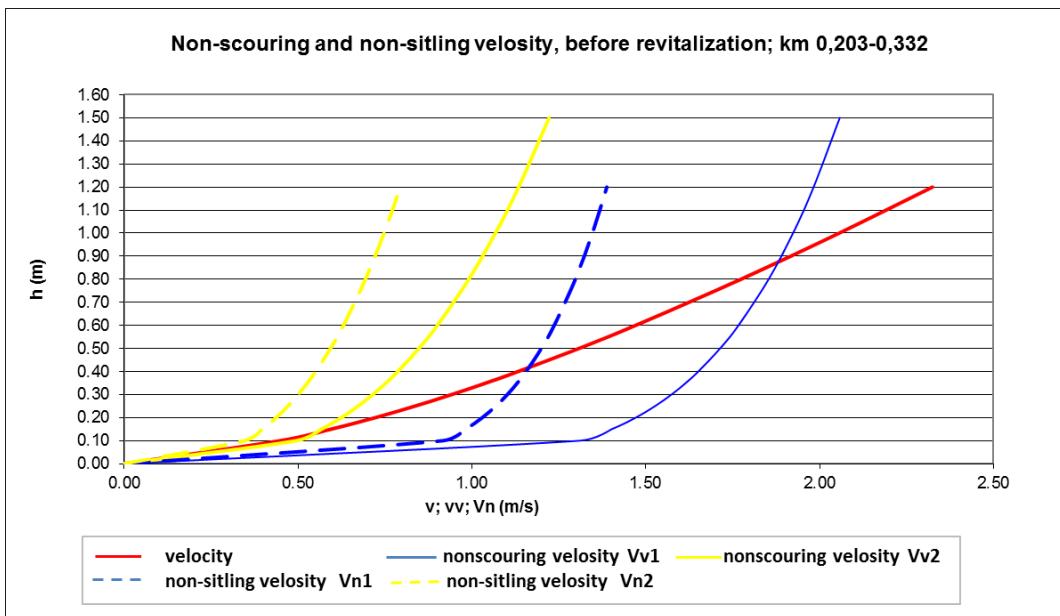
According to the results of calculations Bran finisher and nonscouring speed is evident that the trough is rather unstable and is here to erosion. The flow rate Q_a - long-term average flow, but the results of calculations indicate clogging in the channel. Results in 2008 show that due to changes in bottom paving the trough becomes more stable. Development speed in the channel is characterized by Fig. 5-10.

Fig.6: *Orlické Záhoří-T12, non-scouring and non-settling velocity, after revitalization – 2013*
 (aut. Marková)

Fig.8: Orlické Záhoří-T12, non-scouring and non-settling velocity, after revitalization – 2008
 (aut. Marková)

Fig.10: Orlické Záhoří-T12, non-scouring and non-settling velocity, before revitalization
 (aut. Marková)
