VISUAL, MORPHOLOGICAL AND CONTEXTUAL CHANGES IN DETACHED HOUSING AND HOUSING AREA: KONYA OGRETMEN HOUSES – TURKEY

Dicle Aydin¹*, Berin Dikici Koseoglu²

To cite this paper: Aydin, D., Koseoglu, B.D. (2014). Visual, morphological and contextual changes in detached housing and housing area: Konya Ogretmen houses – Turkey, In conference proceedings of People, Buildings and Environment 2014, an international scientific conference, Kroměříž, Czech Republic, pp. 631-640, ISSN: 1805-6784.

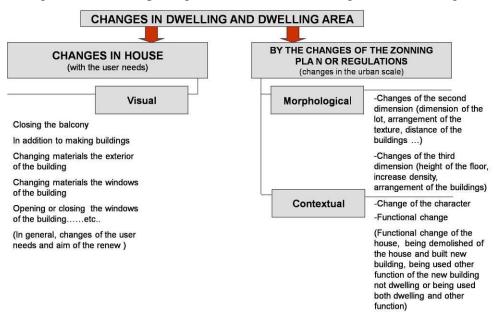
The evaluations were made in terms of parcel and detached dwelling changes depending on the years, and concrete results were aimed to be reached using the tables, figures and photographs by determining the visual, morphological and contextual changes as seen in Figure 1.

Fig.1: Changes in the study area for the analyses

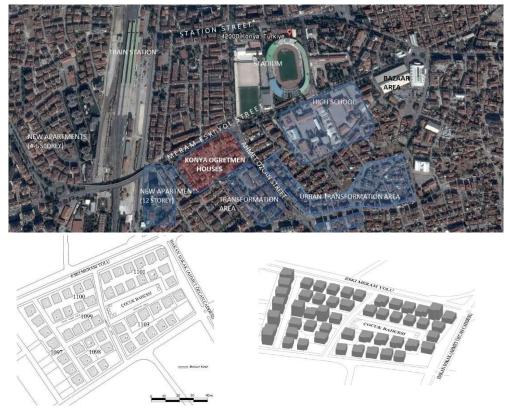
Konya Ogretmen Dwellings have been started to be constructed on six structural islands as a Structural Cooperative Construction established by teachers in 1954. The stadium and the train station respectively located at the northeastern and southeastern sides of the residential area are still observed as landmarks from past to present (Figure 2).

Fig. 2: The location of the Konya Ogretmen Dwellings in the urban area and the site plan [6]

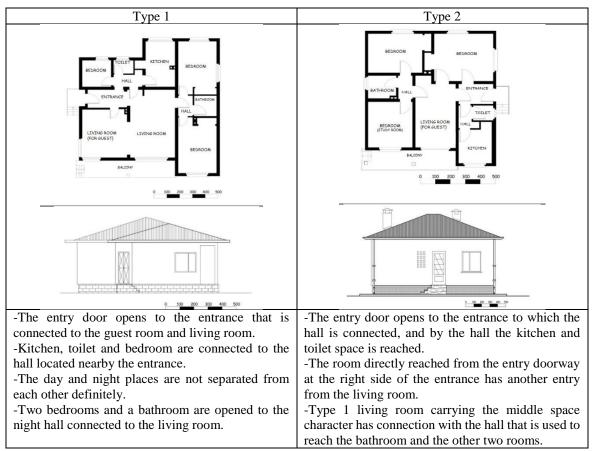
51 dwellings have been constructed in three different types due to the diversity of the user demands (Table 1a-1b) and located parallel to the streets they exist. The entrances of the dwellings of 118 m², 86 m² and 80 – 82 m² were accessed by three stairs and designed to take place at the side façade. The dwellings presenting similar plan schemes have been constructed by the same construction system using the same construction materials.

The number of rooms of the dwellings having square-like shape in general changes the size of the building. The living room has the middle/central space character in every dwelling plan type as a transition space/hall providing the access to other rooms. The detached dwellings had façades to all directions.

Tab. 1a: The types of the Konya Ogretmen houses [6]

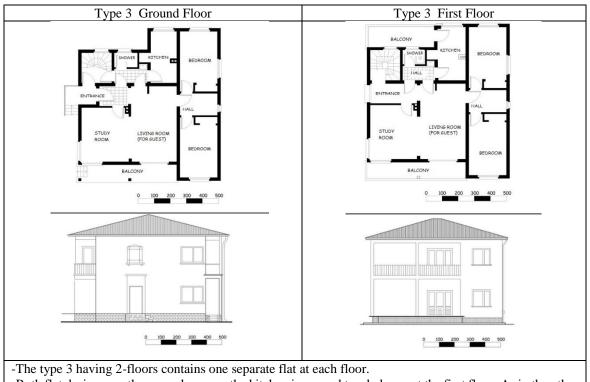
Tab. 1b: The types of the Konya Ogretmen houses [6]

-Both flat designs are the same; however the kitchen is opened to a balcony at the first floor. As in the other types, the layout of the plan scheme is made from 3 halls.

-The first entrance hall is connected to the living room and the second hall from which the kitchen, the shower and the pantry located under the stairs are reached. -From the night hall connected to the living room, you can reach to two bedrooms and the bathroom.

The integrity with outdoor space and indoor-outdoor flow is provided with the living room on the front façade and the spacious balconies/terraces connected with the side space. The window dimensions were determined depending on the function of the space; for instance, the horizontal view design became dominant for the windows of the wet volumes, the living room and guestroom windows were designed as spacious windows to benefit from the daylight.

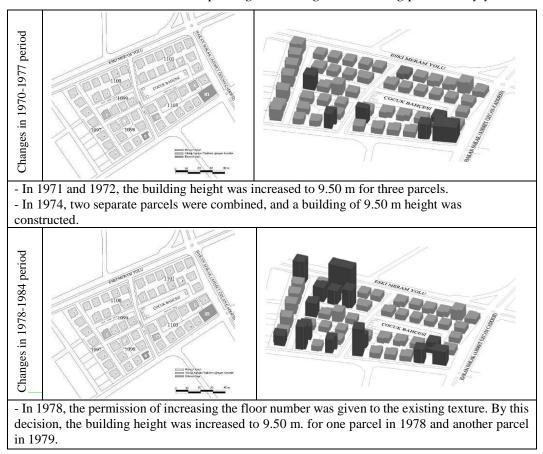
The first cadastral survey for Konya Ogretmen Houses was arranged in 1st April 1968. According to the information on the cadastral survey, the second and third dimension morphological and contextual changes experienced in Konya Ogretmen Houses started in 1970. The changes from 1970 to present are summarized in Table 2a, 2b and 2c.

Tab. 2a: The contextual and morphological changes in housing patterns by year

- In 1985, Municipal Assembly took a decision of "in the southern and southeastern regions of our city, two floors will be added for the parcels having façade to the 14m or wider roads". The first change in the area after this decision took place in 1989 by applying the building height of 15.50m to No.2 parcel having frontage to Eski Meram Road.

-By this decision, the building height in two parcels became 15.50 m. in 1990 and 1991.

-By the revision plan carried out in this region in 1985, 2.70m was added to the existing building height, and there was given permission for increasing the number of floors and building attic flat. -In 1995, No.2 and No.3 parcels were combined together, and the building height was increased to 18.20 m in these two parcels.

-In 1996, the existing building in No.13 parcel was demolished, and a new apartment building of 5.5 storeys was built instead.

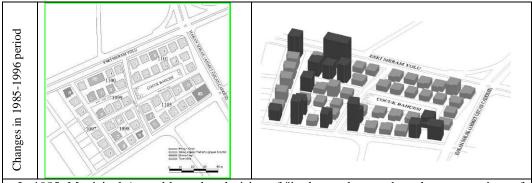
-The existing building in No.6 parcel was demolished, and a new apartment building of 5.5 storeys was built instead. According to 2002 Development Guide's (zoning Regulations)16th topic's d1 clause, the ground floor of the building was used for commercial purpose.

-The existing building in No.7 parcel was demolished in 2009, and a new building of 2 storeys was built instead.

- The existing building in No.4 parcel has been demolished, and a new building of 3.5 storey has been built instead.

-The existing building in No.1 parcel has been demolished, and a new building of two storeys has been built instead.

-The existing buildings in No.2 and No.3 parcels have been demolished, and new apartment buildings of 5 storeys have been built instead.

-The buildings in No.4 and No.5 parcels were subjected to functional changes according to 2002 Development Guide's 16-d1 and 2008 Development Guide's 16-a1 clauses, additionally two buildings were combined together and opened for commercial use.

-The existing building in No.6 parcel was demolished in 2009, and a new apartment building of 5.5 storeys whose ground floor was used for commercial purpose was built instead according to 2008 Development Guide's 16th topic's d1 clause.
