CASE STUDY OF COST-SAVING AND ENERGY-EFFICIENT HOUSES WITH INTERNAL INSULATION SYSTEMS

Václav Hrazdil^{1*}, Michal Hrazdil²

To cite this paper: *Hrazdil, V., Hrazdil, M. (2014). Case study of cost-saving and energy-efficient houses with internal insulation systems, In conference proceedings of People, Buildings and Environment 2014, an international scientific conference, Kroměříž, Czech Republic, pp. 190-202, ISSN: 1805-6784.*

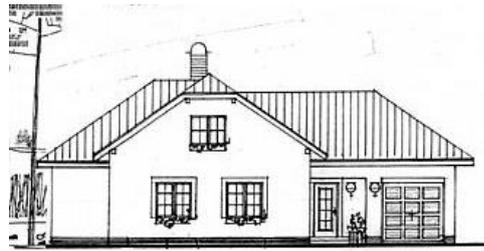
detached house with ground floor and attic in the Moravian-Silesian Beskydy Mountains in the village of Pržno. A schematic view of the south façade is shown in Fig. 1.

Fig. 1: Schematic view of the south façade

The house is covered by a hipped roof and was constructed without a basement. The supporting parts of the 200 mm thick external walls were built of Betong hollow blocks. These masonry units, known as concrete shell building blocks, are manufactured on vibro-presses which Adler imported from France. The concrete mixture determined for the production plant at Ratiškovice near Hodonín contains: dolomitic limestone of fractions 0-4 mm and 4-8 mm, a cement dose of 6-8 % and mixing water. Automated production control ensures precise adherence to mix recipes and that all blocks of one type have exactly the same dimensions. The shell is usually up to 18 mm thick. For blocks kinds – see Fig. 2:
