EFFECT OF MANUFACTURING TECHNOLOGY ON QUALITY OF CERAMIC FLOOR TILES

Bohdan Stawiski¹, Tomasz Kania^{1*}

¹ Institute of Building Engineering, Wrocław University of Technology, 27 Wybrzeże Wyspiańskiego St, 50-370
Wrocław, Poland

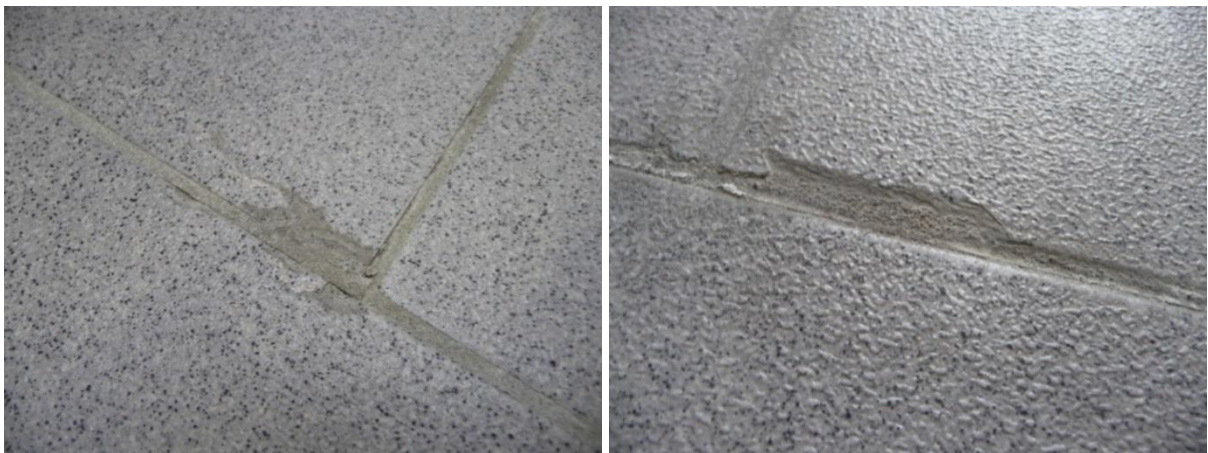
Fig. 1: Typical damage of ceramic tiles in the new floor

The tile floors in both halls became damaged. To a smaller but essential extent in the new hall, and to a very high extent in the old hall. In the new hall, none of the tiles broke, while their corners and sides were quite commonly chipping off (fig. 1).

In total, 30 tiles in the floor and 6 purchased tiles (new) were examined. In the case of tiles built in the floor, only damages of corners and edges, shown in fig. 1 were visible. In the case of new tiles, it turned out that approx. 50% of elements in the package had other types of damages resembling stratification across the depth visible on their side edges (fig. 6).

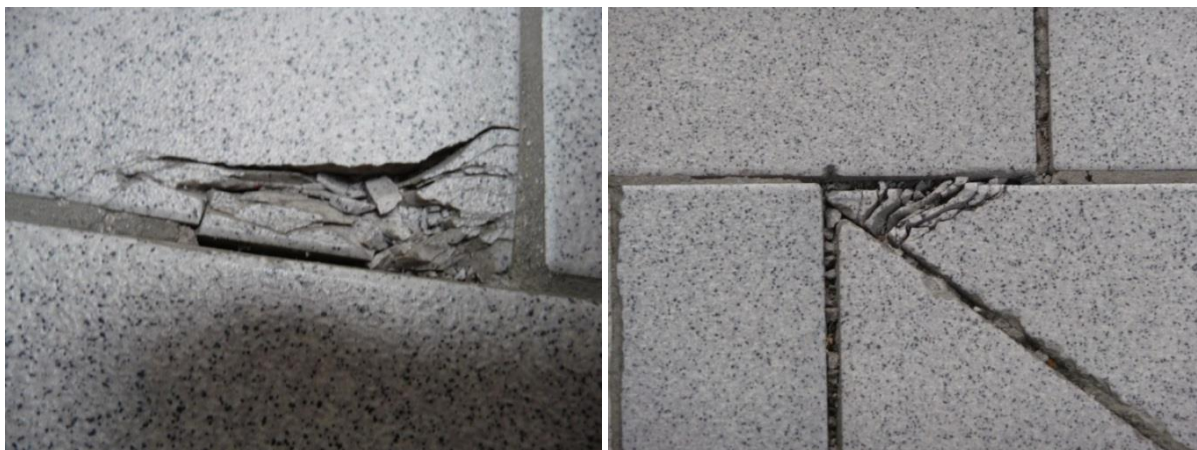
Fig. 2: Typical damage of ceramic tiles in the old floor

The floor used for the period of approx. 3 years showed significant damage (fig. 2), however the places of damage were similar (corners or end fragments of the tiles).

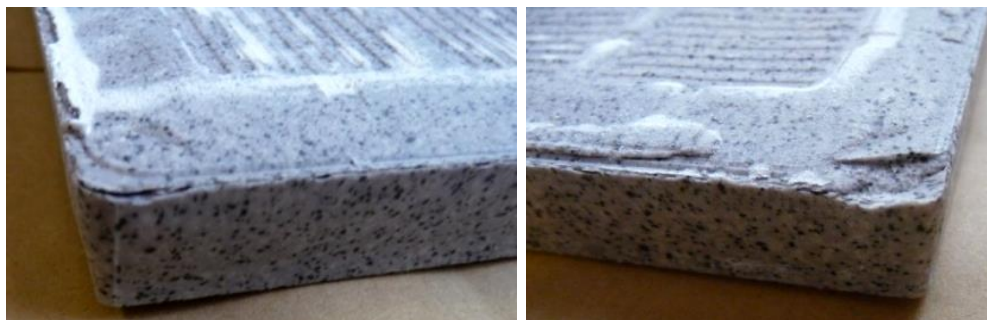
Fig. 6 Examples of new pressed ‘gres’ tiles with damages on side edges.

The damages shown were not regarded as defects by the manufacturer because they did not have any influence on the value of breaking force controlled according to the standard [3].

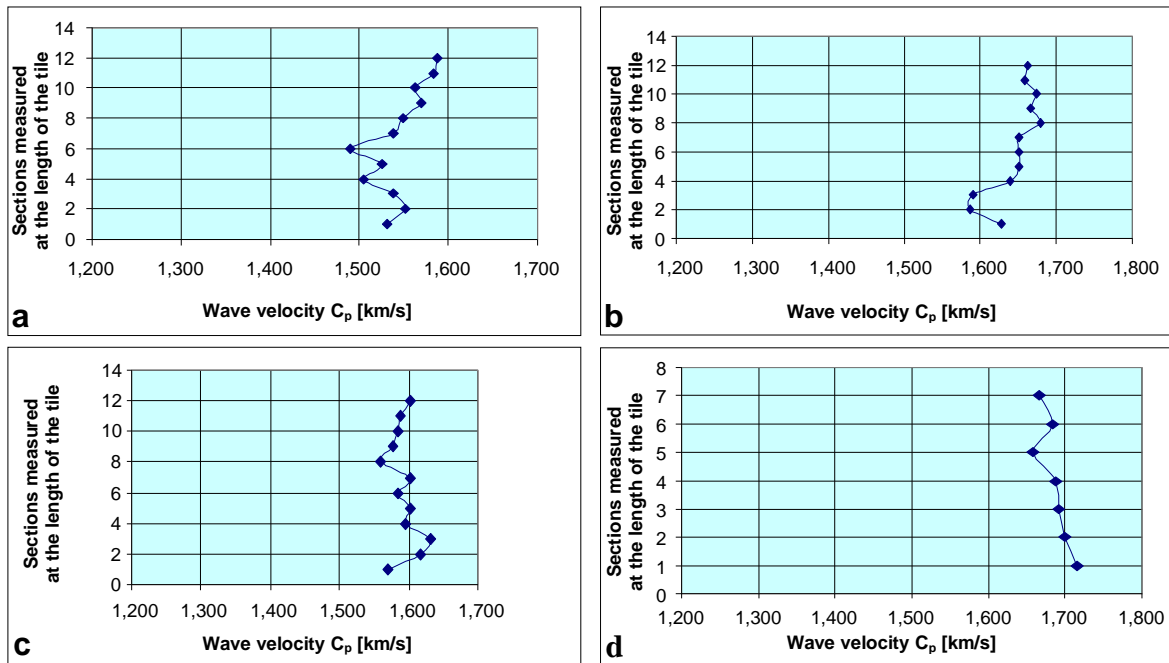
Fig. 7 Surface wave velocity C_p [km/s] in the 12 tested cross-sections along the length of 'gres' pressed tiles which did not have any damage: a, b – tiles built in the floor, c, d – new tiles. Standard deviation $S \leq 0,029$ km/s

The conducted tests indicate that in tiles without damage, regardless of the fact whether they were built in or newly bought, change of surface wave velocity C_p in individual measurement sections was small. Figures 7 a and 7 b shows the examples of results of surface wave velocity tests in the measured sections of tiles without damage, that has been built in the floor. Figures 7 c and 7 d shows the examples of surface wave velocity in measured sections of the new, disused tiles without damage. Numbers of measurement sections along the tile lengths were shown on the vertical axis.

The obtained charts indicate that these tiles have a relatively evenly compacted structure along their length. Even though velocities in each of them were not the same, the built in tiles did not get damaged. The tiles not built in also did not have any damage from the production stage. The difference of wave velocity C_p between the weakest and the strongest cross-sections (spread) did not exceed 100 m/s. Standard deviation didn't exceed the value of 0.029 km/s.

Undoubtedly, the most convincing interpretation of the results is obtained by graphic presentation of them in the charts (fig. 7- 9). Statistical parameters, such as: spread, arithmetic mean and standard deviation, also characterize well quality of the tested floor tiles.

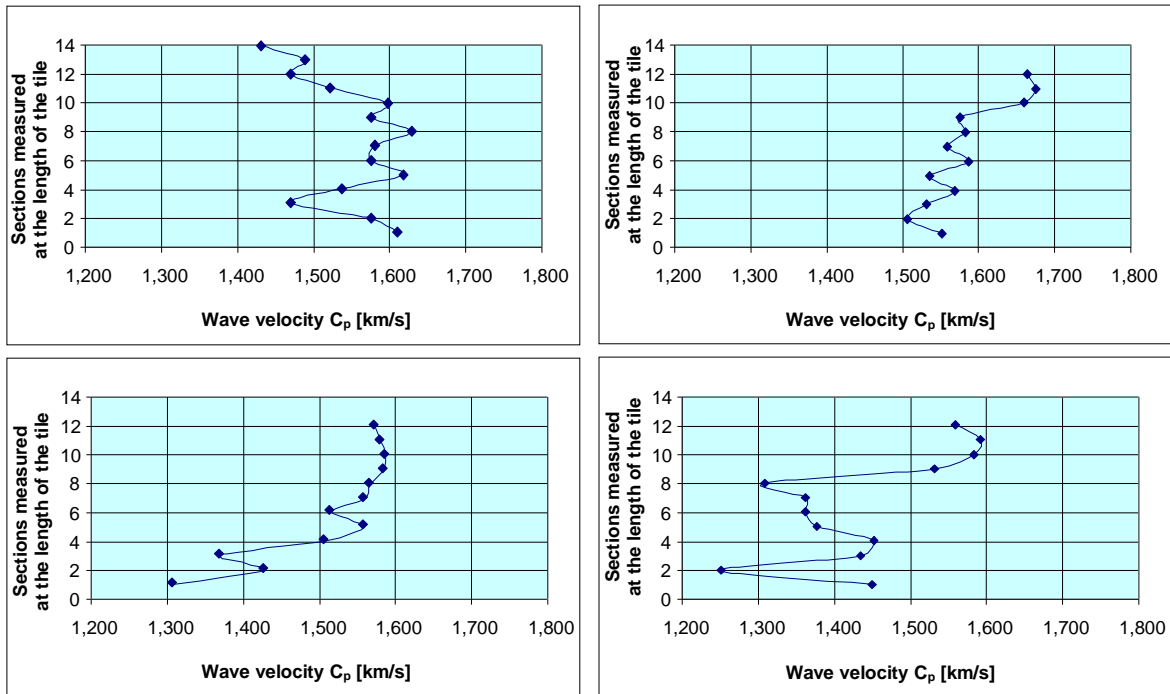
Fig. 8 Surface wave velocity C_p [km/s] along the length of pressed tiles in which damage occurred. $S \gg 0,03$ km/s

Figure 8 shows the examples of surface wave velocity in measured sections of built in the floor and new tiles with visible damages. Progress of velocity C_p that appears in tiles with damages is completely different than in tiles without damages. In tiles with damages there was always the tendency of change in wave velocity C_p coming from one end of the tile to the other end.

The difference of velocity between the highest and the lowest value is much higher than in tiles without damage, it was 200 – 300 m/s. Standard deviation reached the value of 0.080 km/s. The nature of ultrasound velocity changes presented in fig. 8 indicates uneven pressing of ceramic substance in the mould which undoubtedly shows the need to improve the pressing method.
