INVESTIGATION OF TECHNICAL CONDITION OF EXTERNAL THERMAL INSULATION COMPOSITE SYSTEM WITH MICROBIAL ATTACK

Nad'a Antošová^{1*}, Katarína Minarovičová²

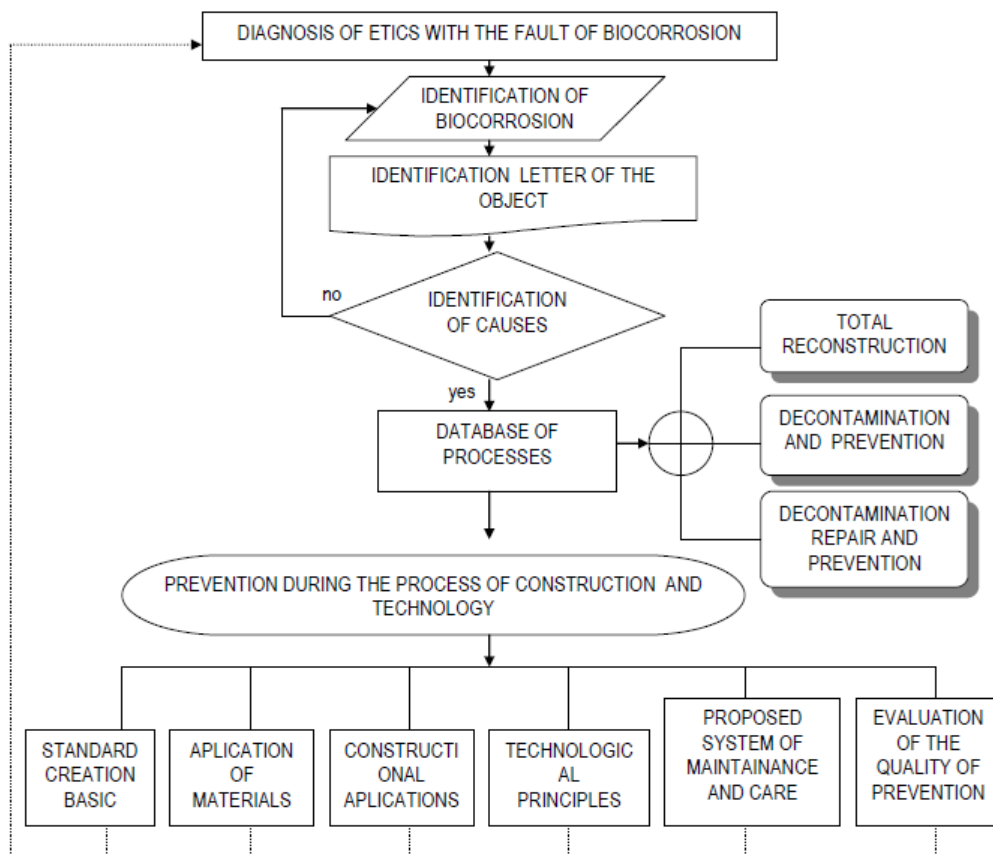
Fig. 1: Method of investigation of ETICS with microbial degradation and use of diagnosis [16].

the functionality of external insulation is explained at Figure 1. According to the type of intervention during investigation of ETICS (Fig. 1) following methods are used:

- non-destructive (indirect) - in which the strata is not broken or is minimally broken. This includes visual survey, a collection of biological material by means of smear, laboratory culturing of biological material, measuring the size of tears, moisture measurements, measurement of surface temperatures, temperature field imaging, testing the acidity of the environment, setting the area of bio-corrosion [2].

- destructive (direct) - these methods require structural failure due to sampling the entire strata of thermal insulation composite system. The most common way is to perform a probe to investigate the layers of strata, technology of construction, laboratory verification of physical properties of particularly plasters and also penetration of biological material in the strata [2]. The method is used when non-destructive method does not lead to the required determination of the extent of damage, followed by proposals for treatment. Microbiological samples from thermal insulation surface are due to environmental exposure covered by a number of inorganic and organic materials (pollen, dust, soot and even soil.). Their laboratory studies cannot be done without laboratory cultivation that results in isolation of pure culture of micro-organisms, usually micromycetes. This process is very specific, time consuming and technically challenging.

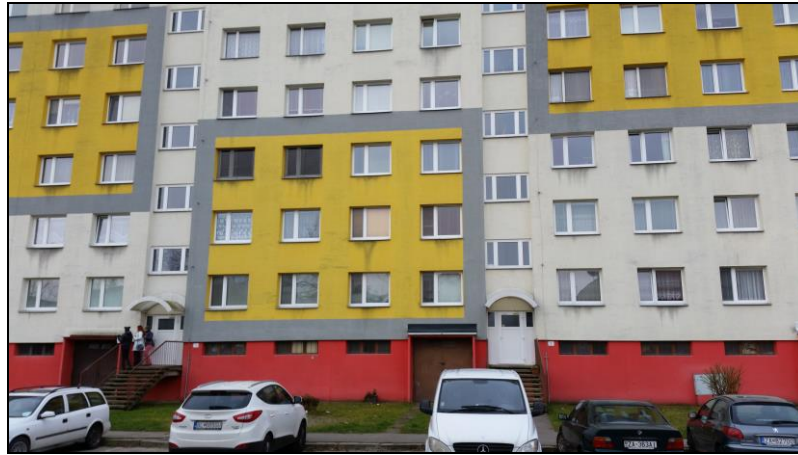
Fig.2: North facade – local contamination show process of water run-off from sill or thermal bridges in window to sill joints. (Antošová)

Sampling and subsequent mycological analysis of the external environment of a block of flats in Bratislava (Fig. 2), was conducted within the local examination (Fig. 5-6). When sampling, the relative air humidity was 67.9% and outside air temperature was 7.8 ° C. An air sample was obtained (airborne fungus with the possibility of deposition on the examined surfaces - the façade) and samples from the external surfaces of buildings [7].

Initial superficial evaluation of thermal insulation with bio-corrosion that was based on visual exploration, resulted in the assessment as aesthetic deficiency, without finding surface breaking cracks, peeling off and other deformation of the structure. Colonization of the investigated surface area exceeded the value of 25%, and local colour soiling has been detected. Protection of micro-organisms with slime was not observed. Destructive method has been performed to verify the penetration of micro-organisms into the strata. The results confirmed the doubts about the severity of the technical condition of ETICS.

According to the results of the investigation, it is possible to assess the identified condition in 3stage rating scale as normal, common defect. There are not recorded cracks and other defects on ETICS surface, colonization of an area is in the range of 25% and more, that is considered as level 5 Severity classification rating scale -as major pollution. Recorded consequences however, can be corrected or repaired by routine repair and subsequent maintenance.

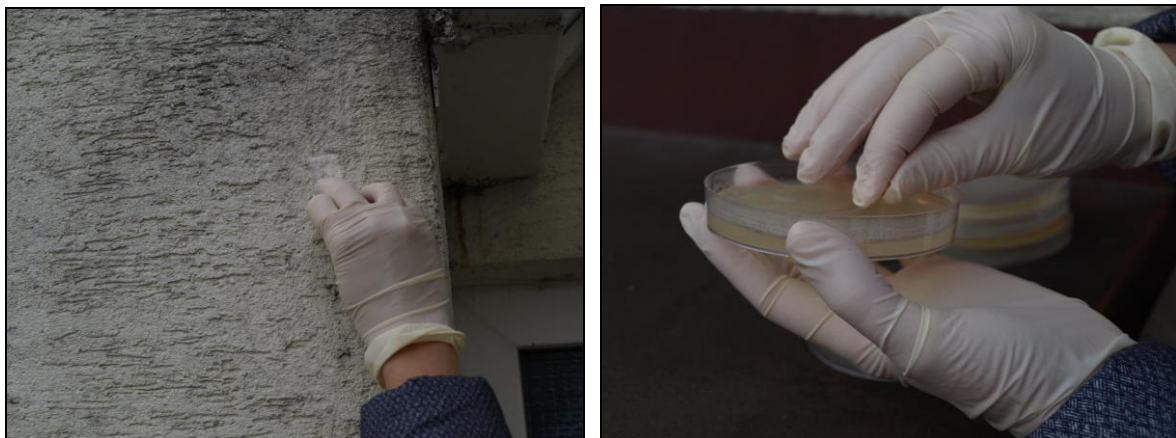
Fig.3, 4: Taking of samples with sampling tape (Fungitape) from the surface of contaminated plaster. (Antošová, Piecková)

- examined façade with different coloured finish with no visible fungal increase,
- examined façade with grey, black and green spots possible fungal to algae growths (fig 3, 4),
- holes by destructive probe from ETICS plasters (fig. 7),

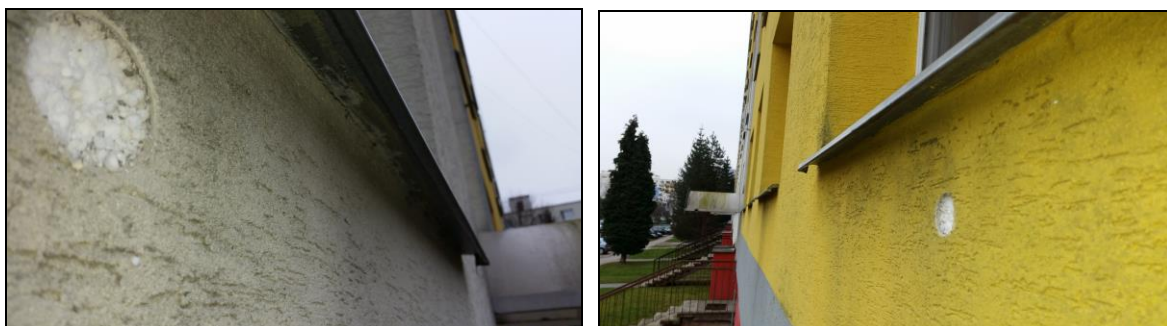
Fig. 5, 6: Localization of sampling.

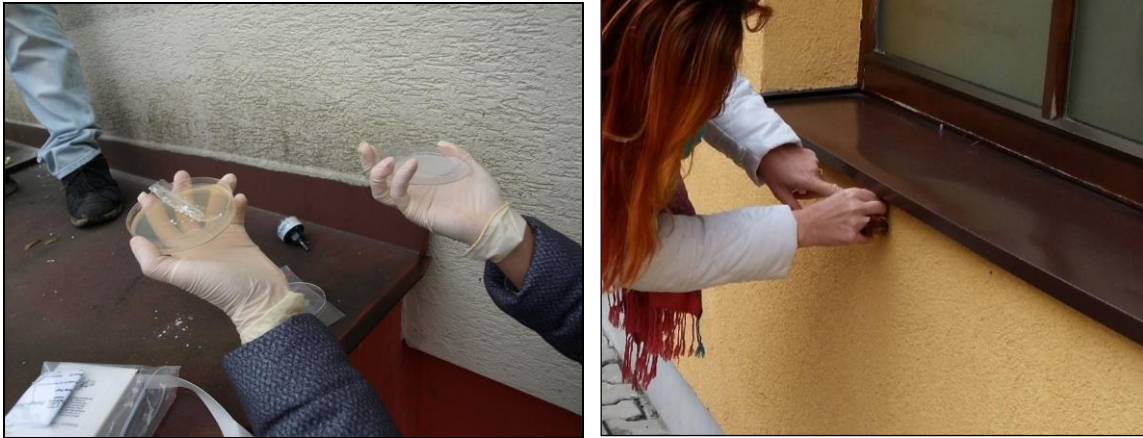
Fig. 7: Sampling by tape from the strata under the plaster. Fig. 8: Sampling of surrounding façades- without insulation- for comparison.

- samples from control buildings opposite the examined façade with no visible colour change, green or black deposits (fig. 8), one plaster was of the same type on the insulation construction and another plaster based on lime.
